Service Bulletin

Bulletin No.: 20-NA-142

Subject: Shudder/Surging While Driving

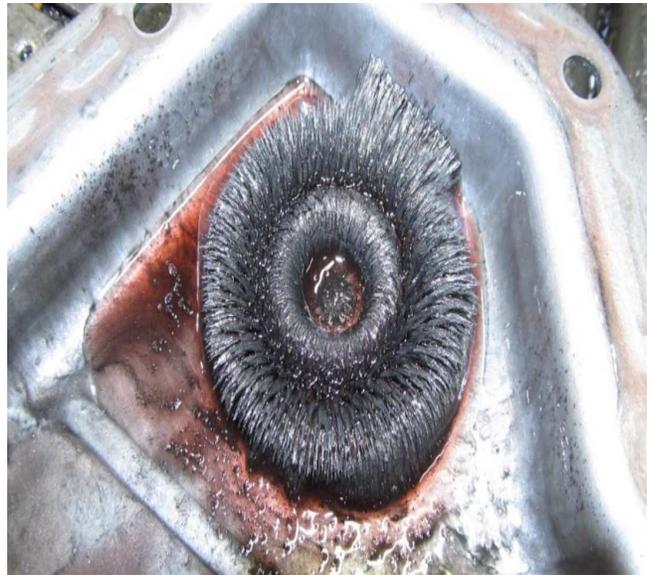
5360216

Involved Region or Country	North America, Russia, Middle East, Israel, Palestine, Chile, Columbia, Ecuador, Paraguay, Peru and Thailand.
Condition	Some customers may comment that a surging condition is felt when driving. Some technicians may find during diagnosis or performing PIP5504F, may identify the surging as a torque converter shudder.
Cause	This condition may be caused by additives in the transmission fluid may have been depleted during vehicle operation. – Some of these additives assisted with regulating a consistent slip rate of the clutches.
Correction	<ol style="list-style-type: none"> 1. Raise the vehicle. 2. Remove the transmission pan.

- If metallic debris is present remove transmission and replace torque converter, replace filter. Refer to *Torque Converter Replacement* in SI.
- If metallic debris is not present replace the transmission filter, reinstall transmission oil pan and perform the steps in the Service Procedure below.
